## Robinson Helicopter Company Accident Report

AIRCRAFT MODEL:	<u>R44 Clipper I</u>
SERIAL NUMBER:	<u>1295</u>
REGISTRATION:	<u>N7530R</u>
ACCIDENT DATE:	<u>30 January 2018</u>
ACCIDENT LOCATION:	<u>Newport Beach, California</u>
NTSB IDENTIFICATION:	<u>WPR18FA077</u>

REPORT WRITTEN BY: Ken Martin

DATE: 17 June 2019

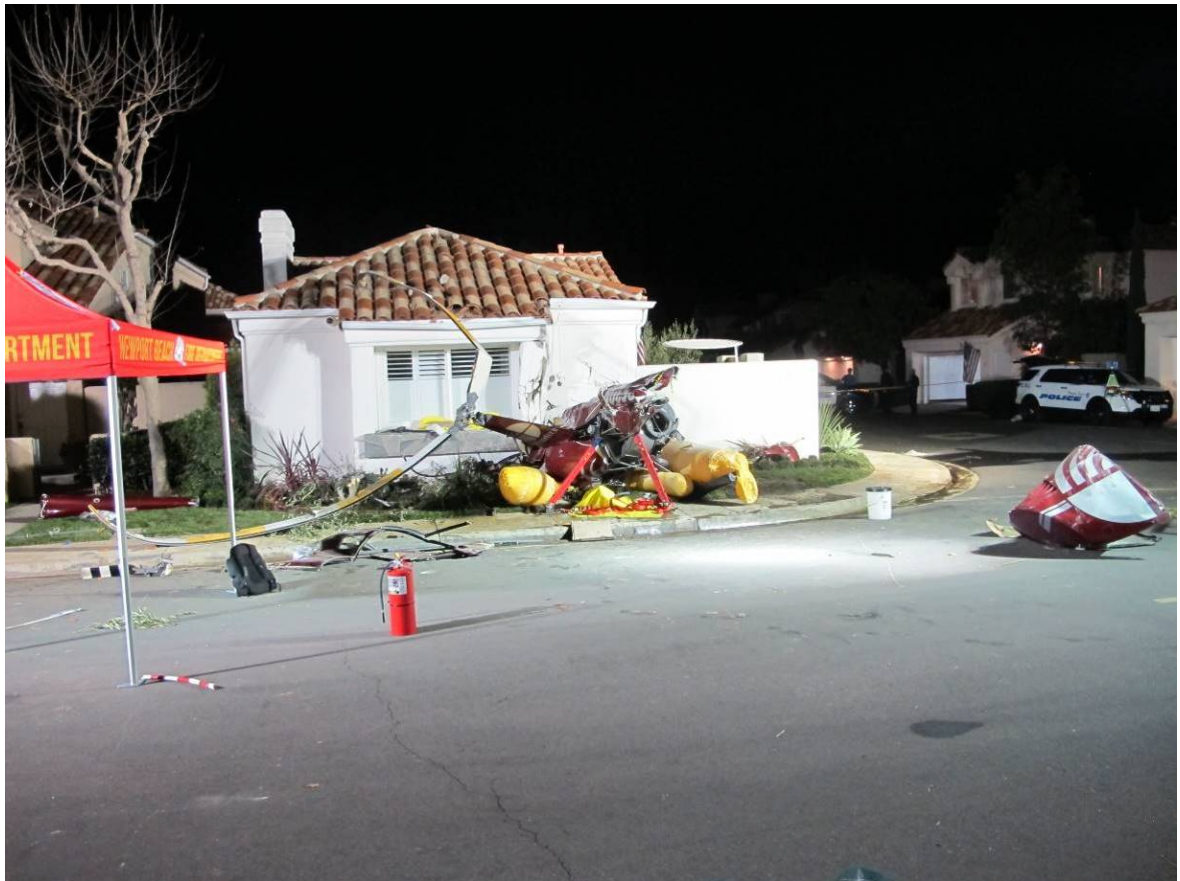
View looking approximately west at accident site

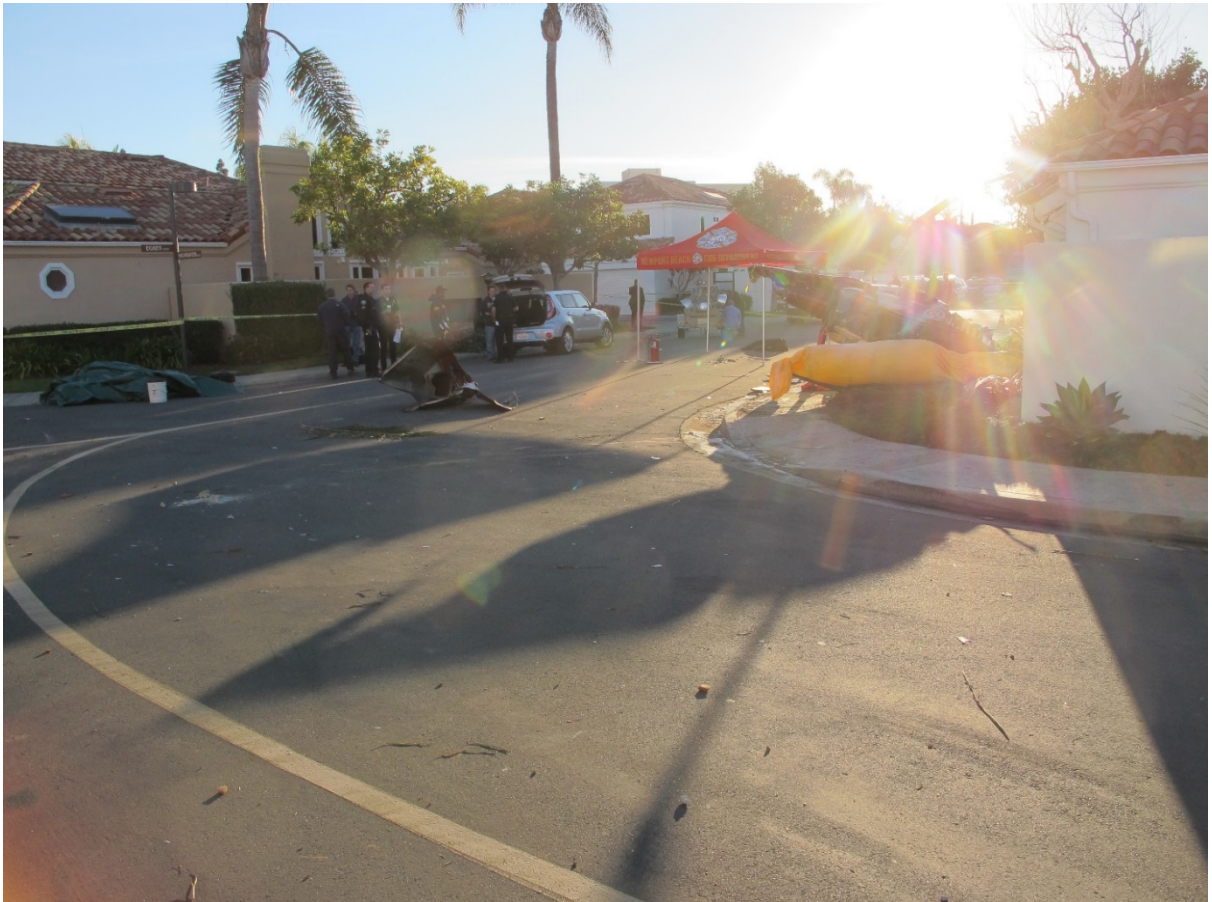
View looking east at accident site

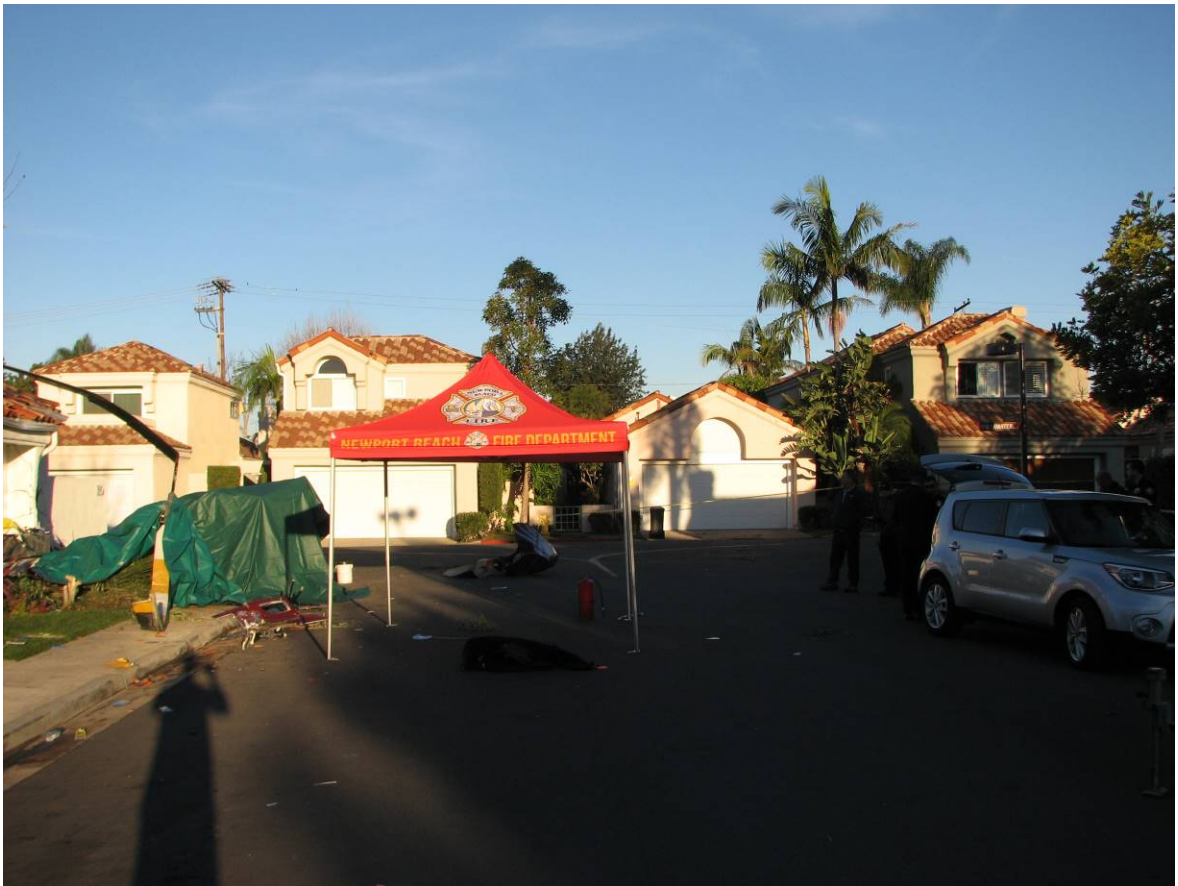
View looking approximately northwest at accident site

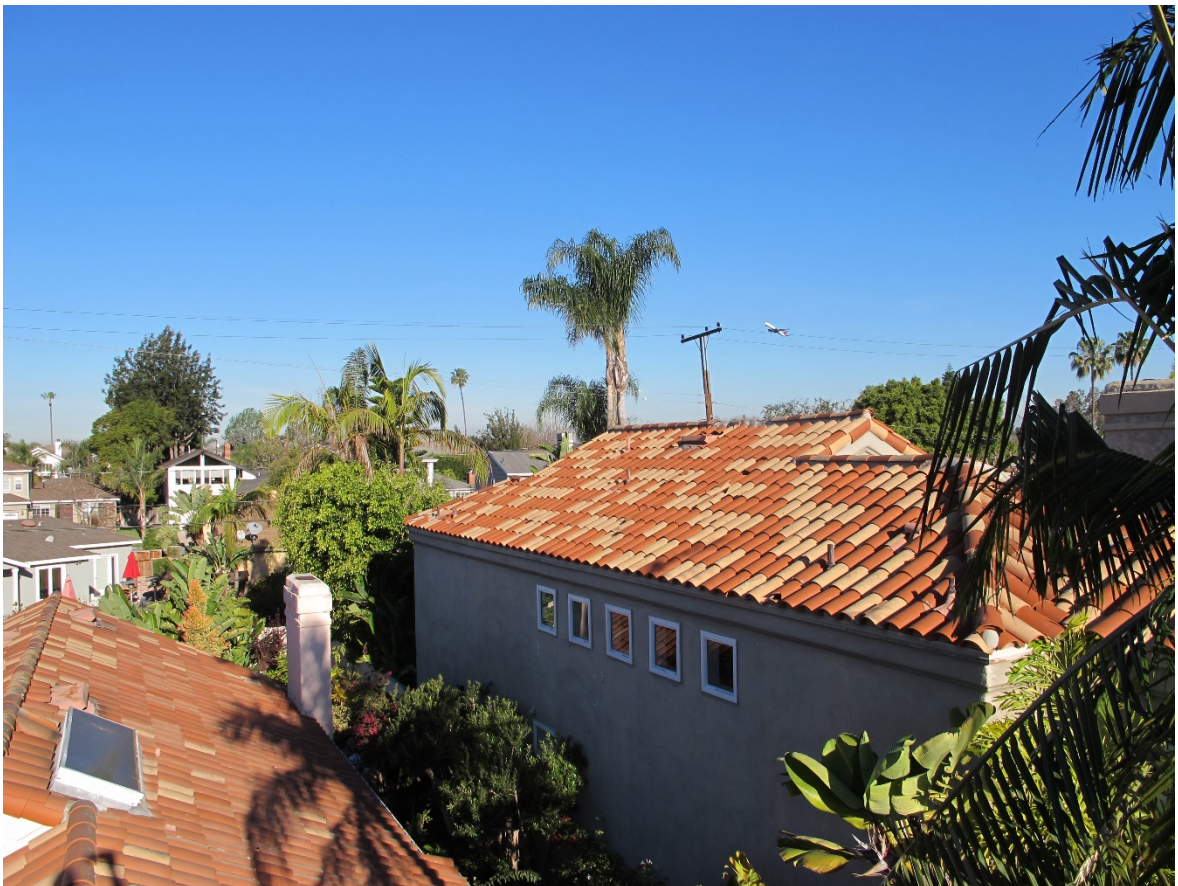
View looking north from the fire engine ladder outside the garage at 45 Shearwater Place

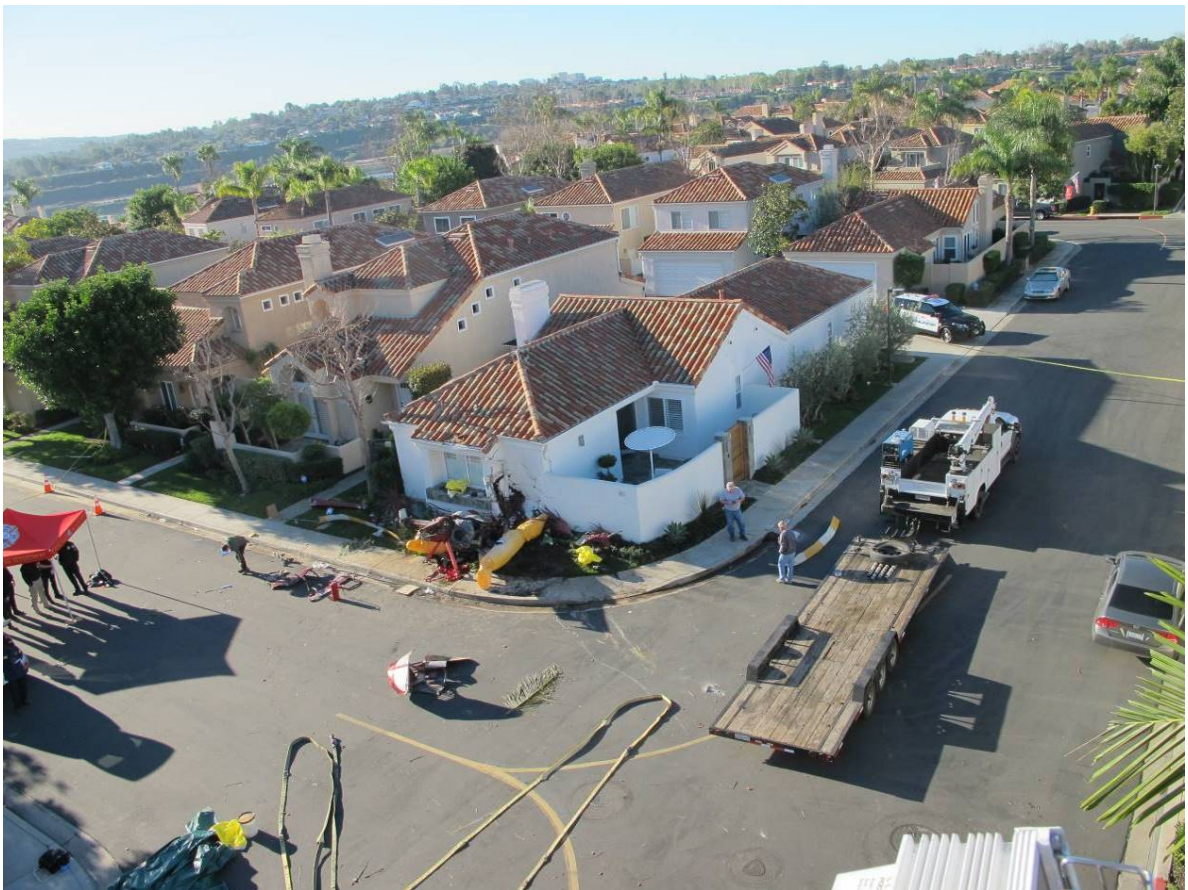
View of the houses at, and around, 41 Egret Court looking south from fire engine ladder

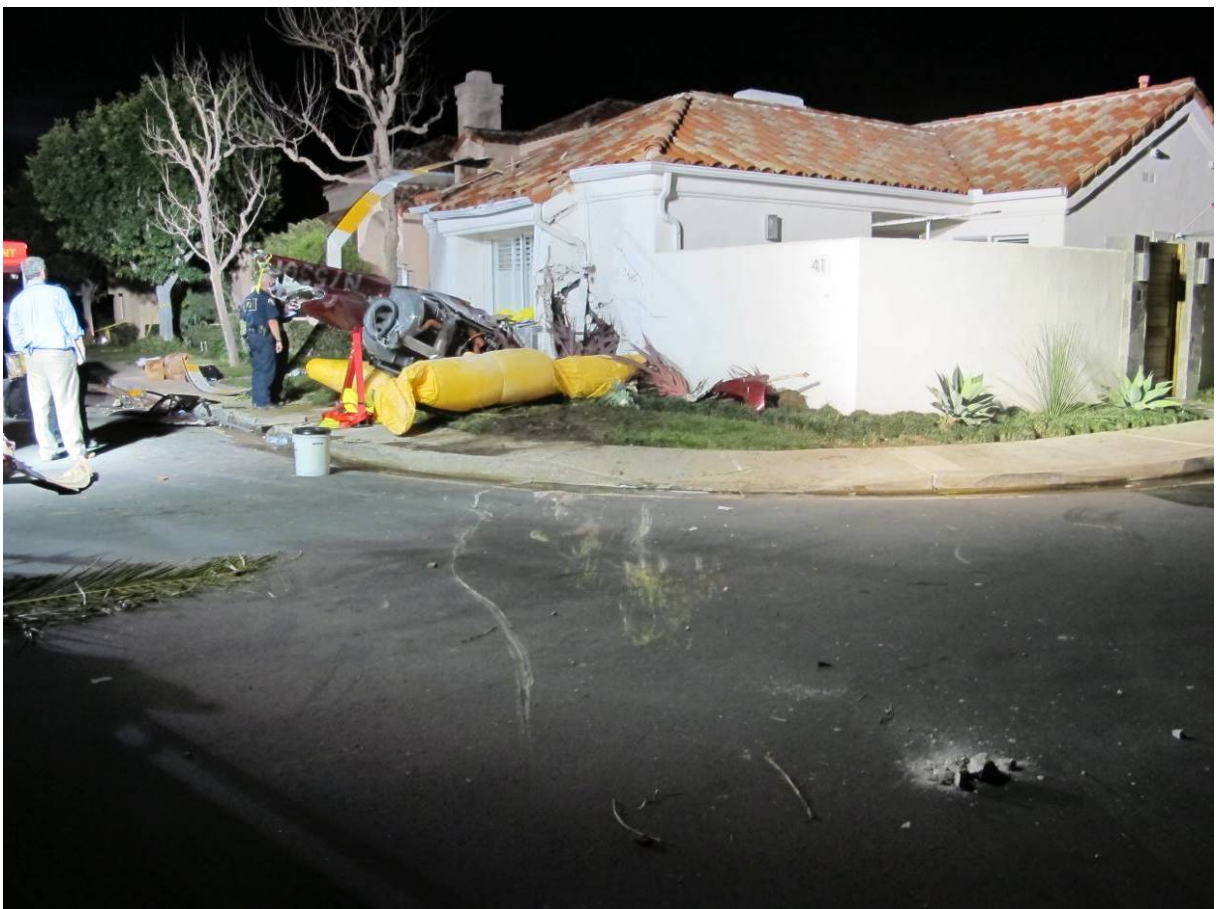
The aircraft at the accident site

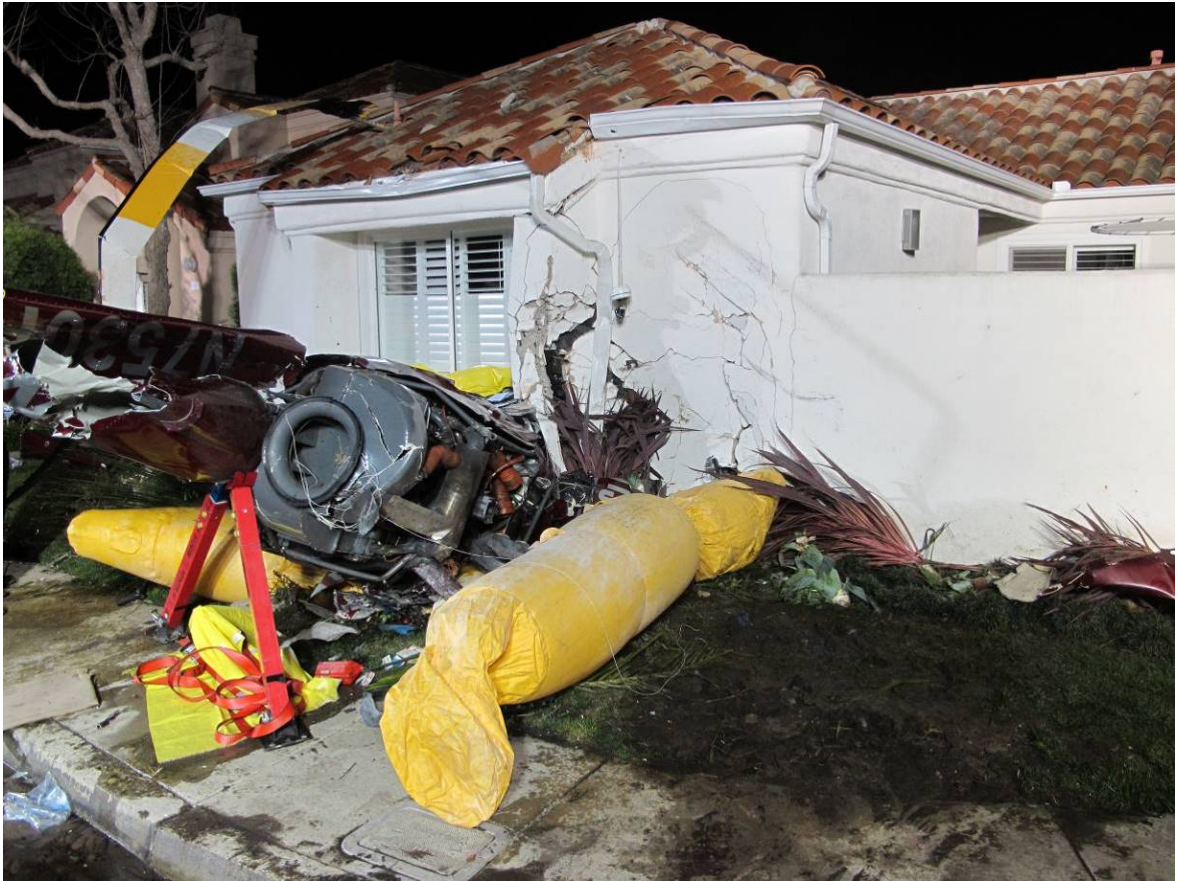
The aircraft at the accident site

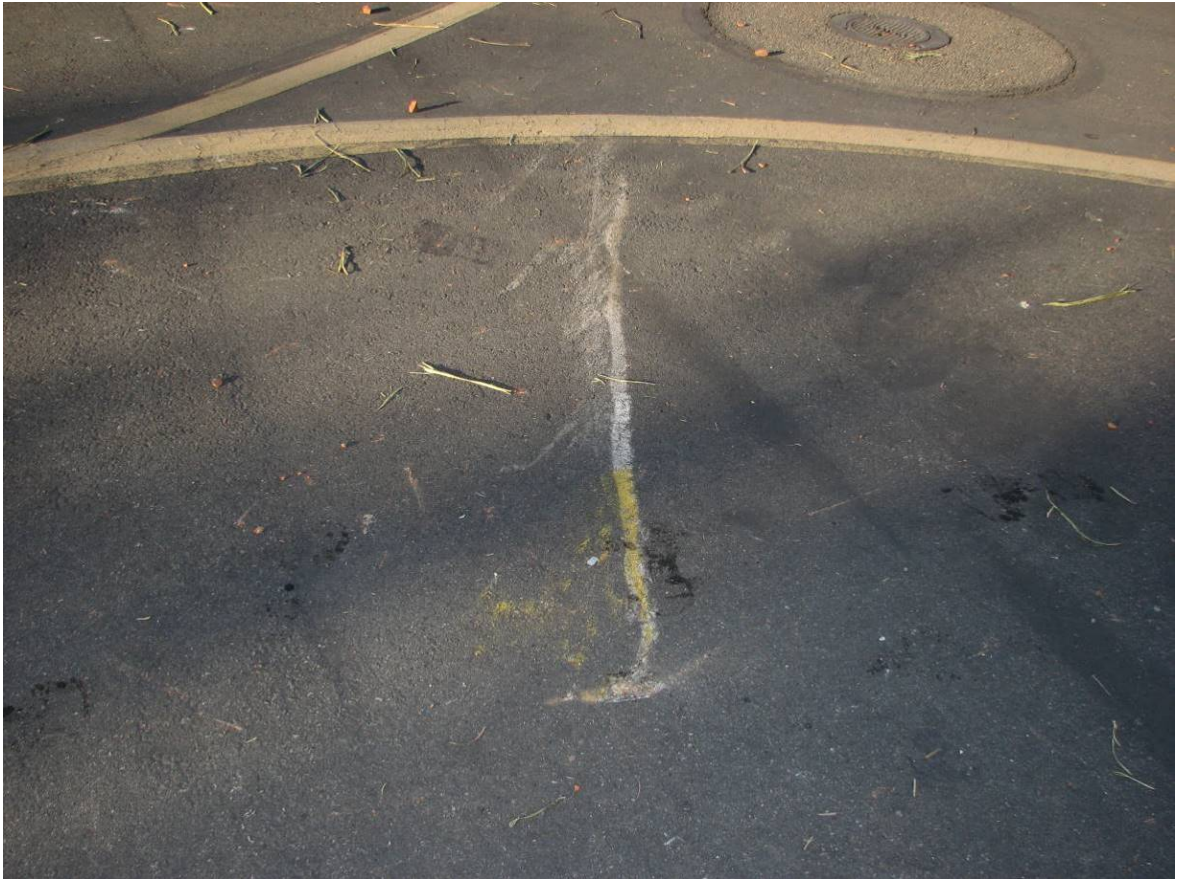
Ground scars and paint transfer in the street near 41 Egret Court

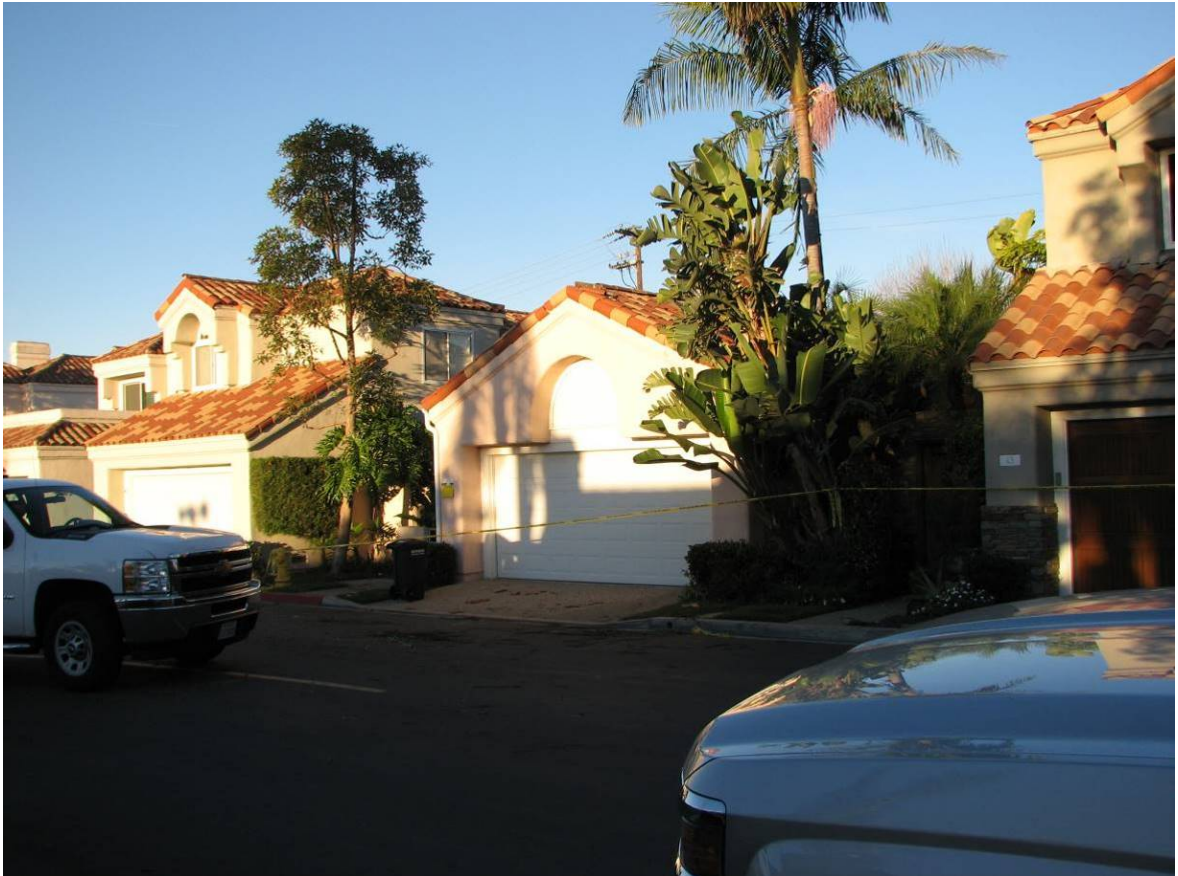
The garage of the house at 45 Shearwater Place

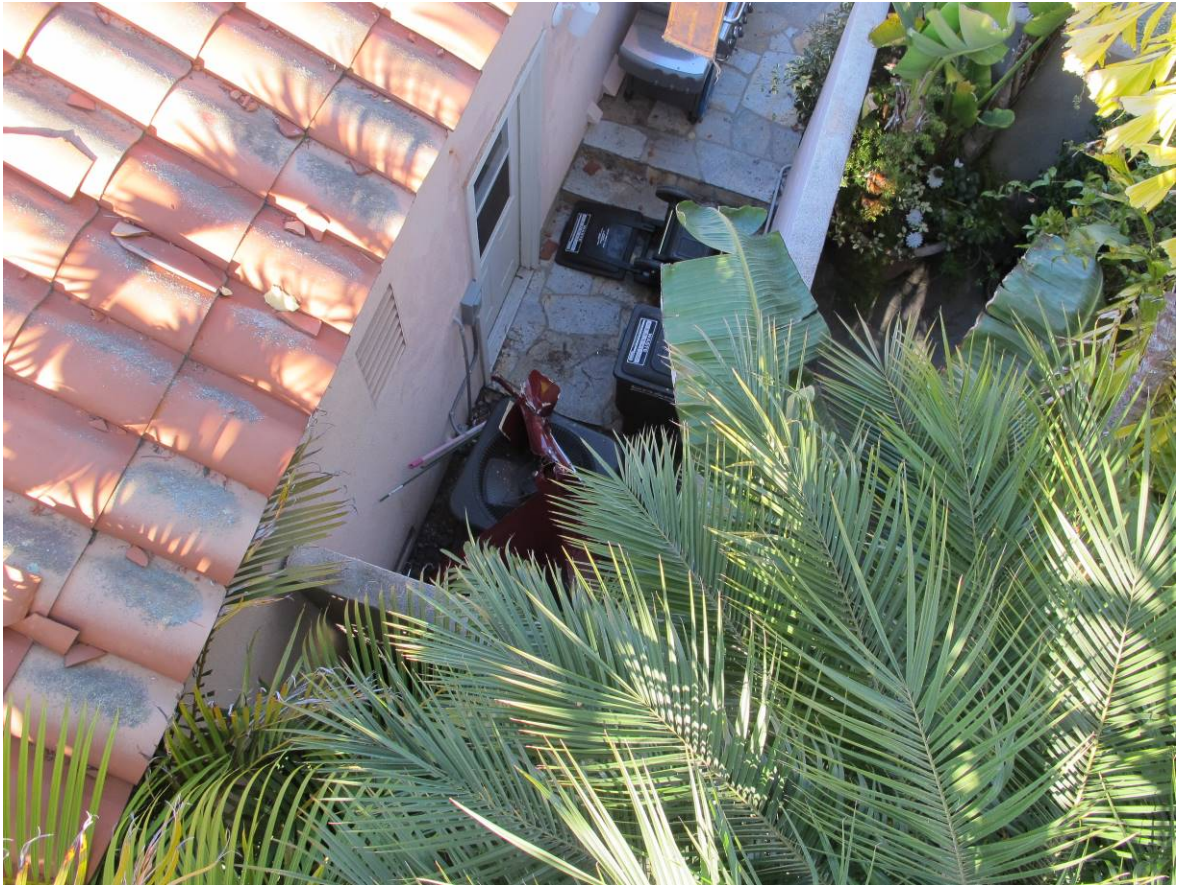
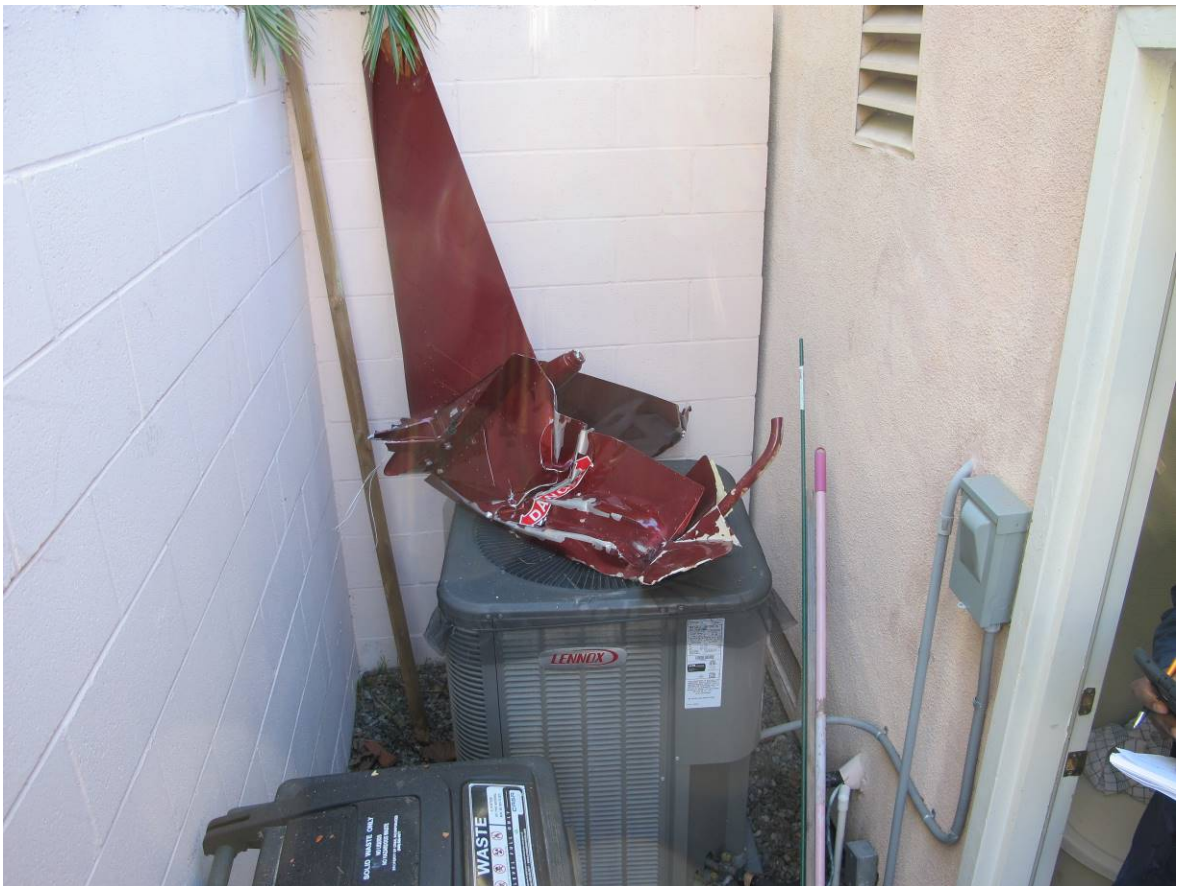
Above and below: The empennage as it was found per the wreckage distribution diagram

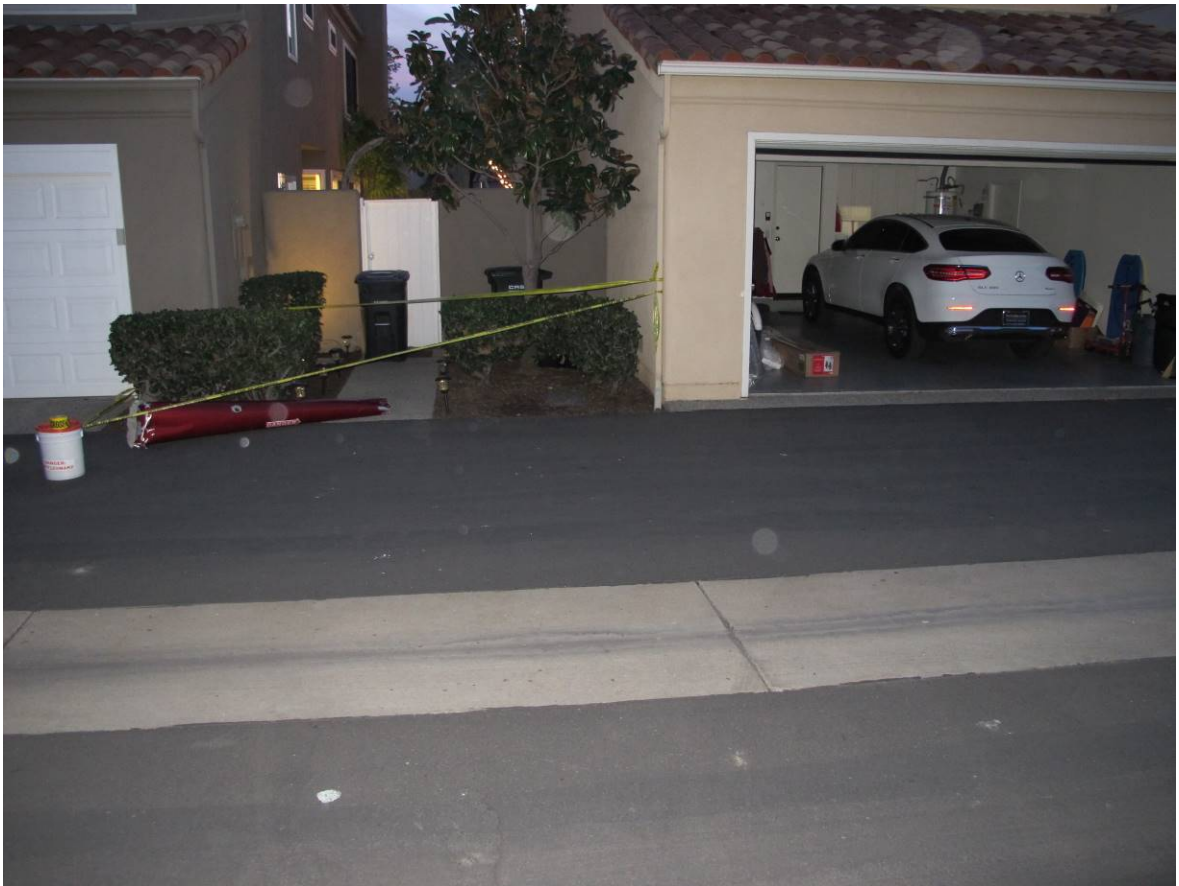
The aft end of the tailcone as it was found per the wreckage distribution diagram

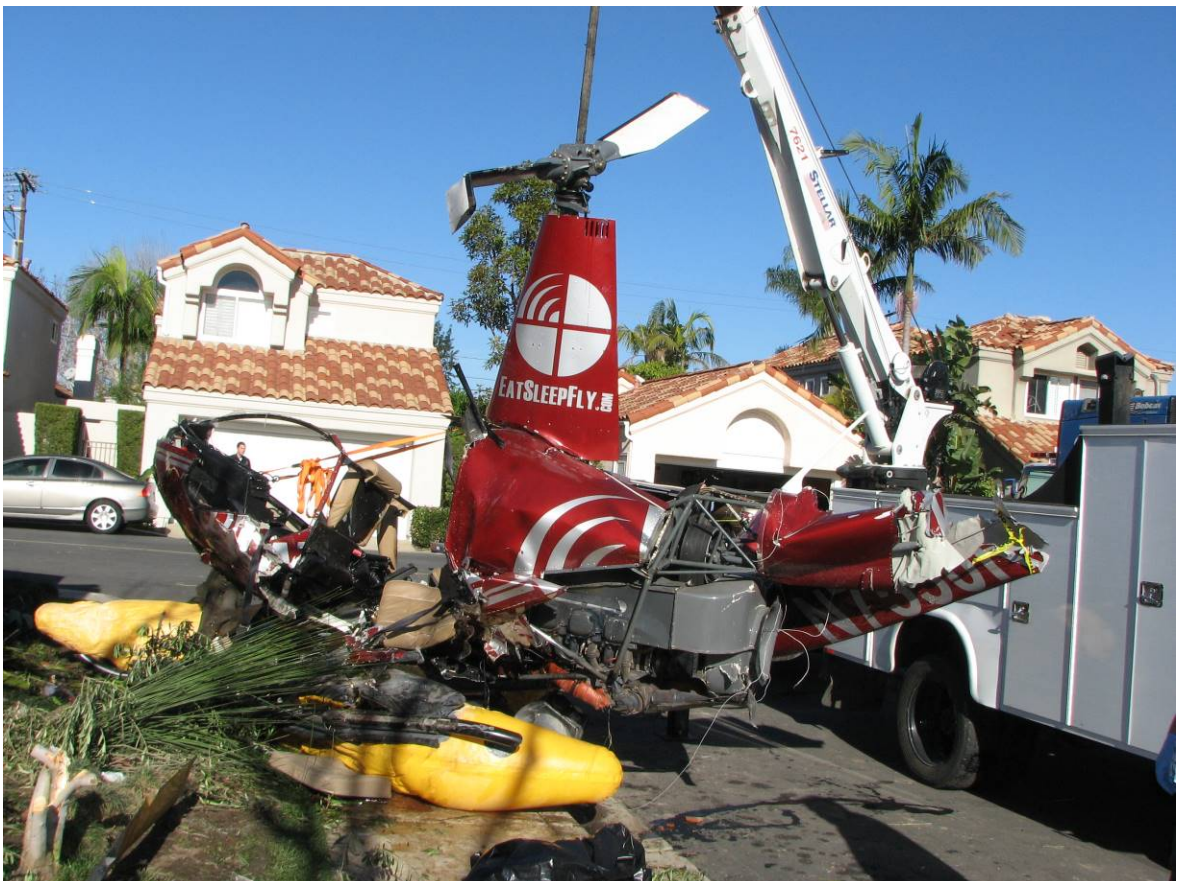
The aircraft during recovery

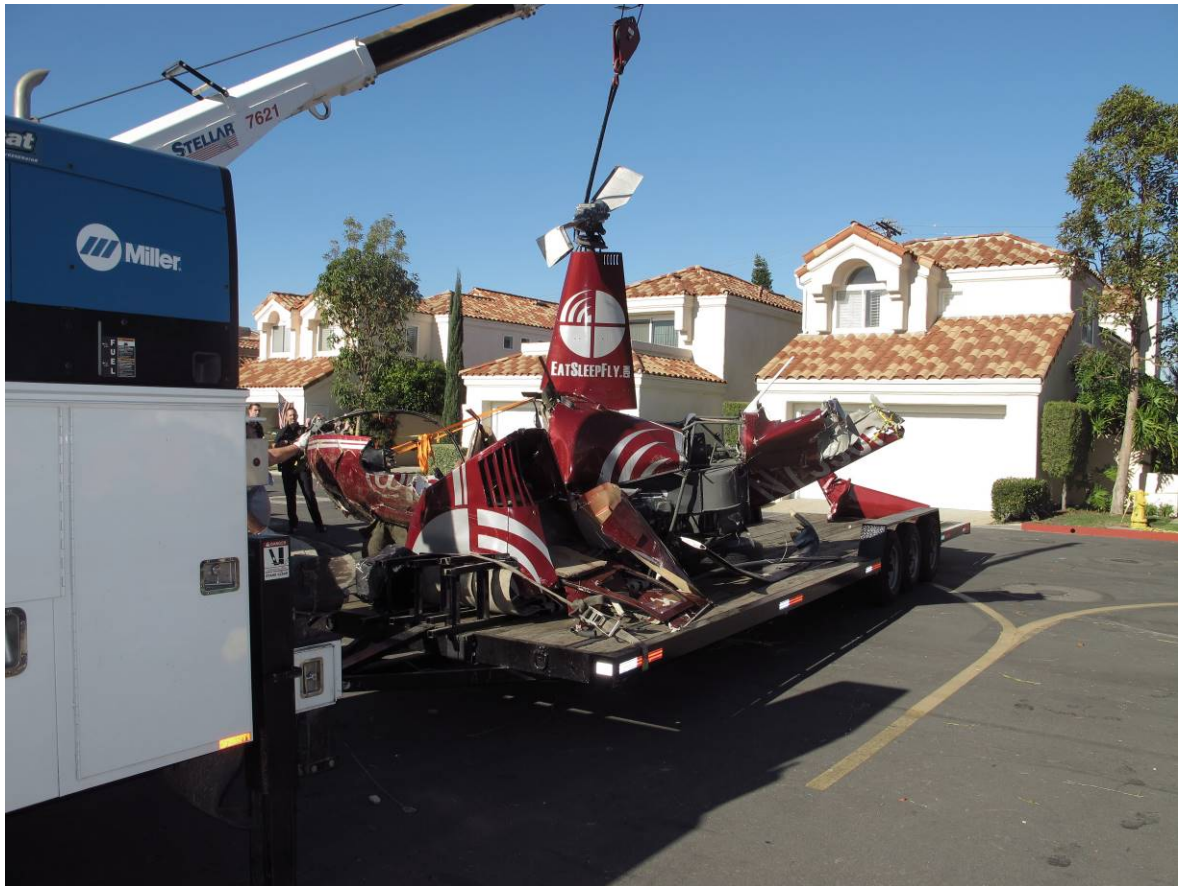
The aircraft during recovery

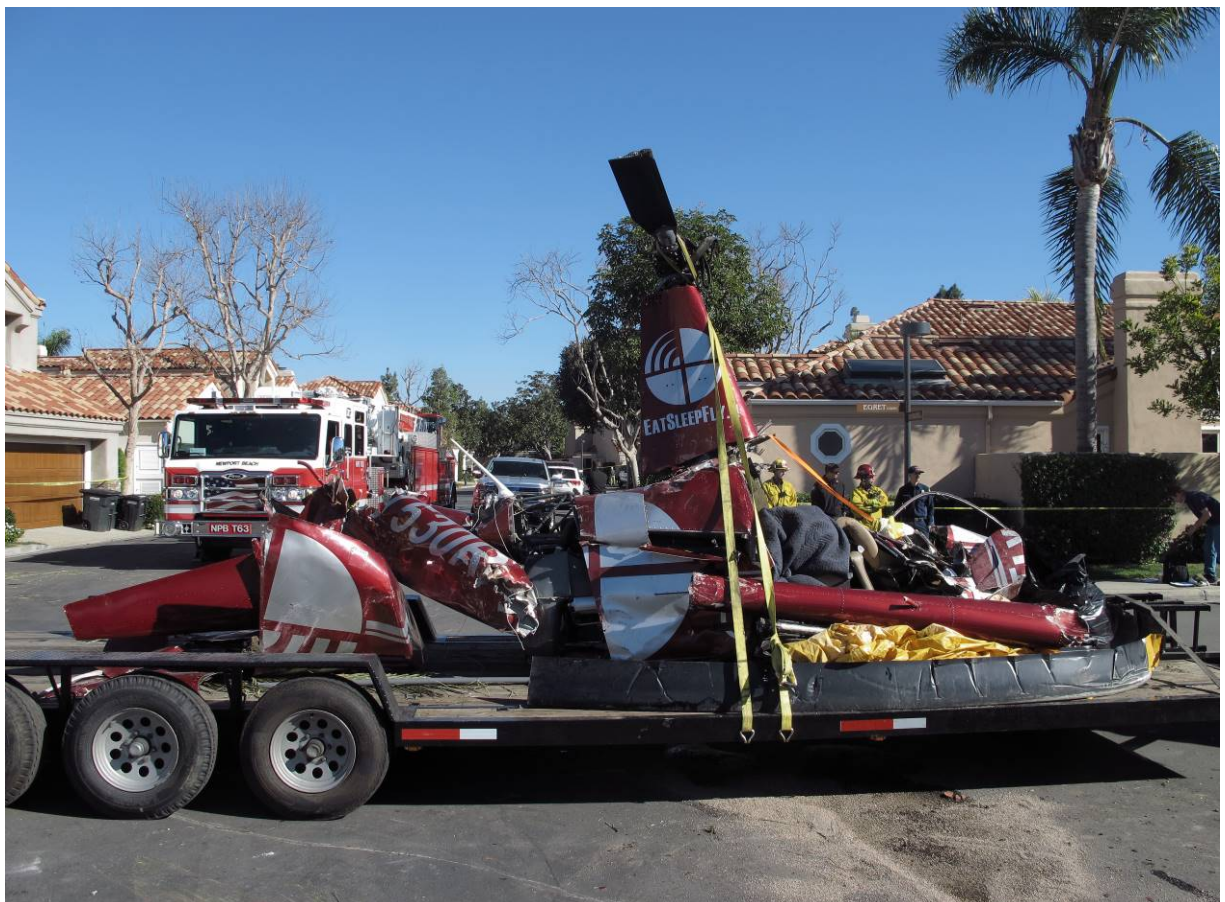
The aircraft during recovery

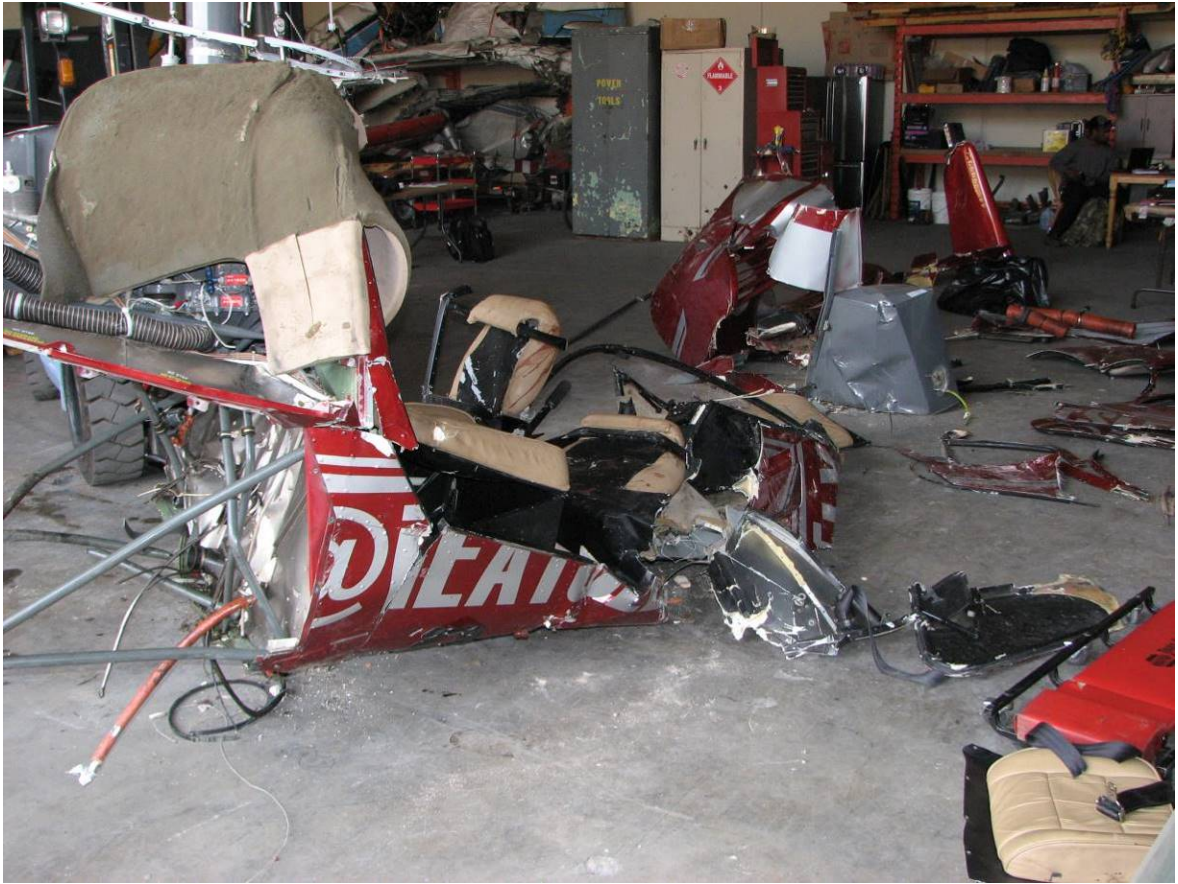
The wreckage as examined at the facility of Southwest Aircraft Recovery in Norco, CA

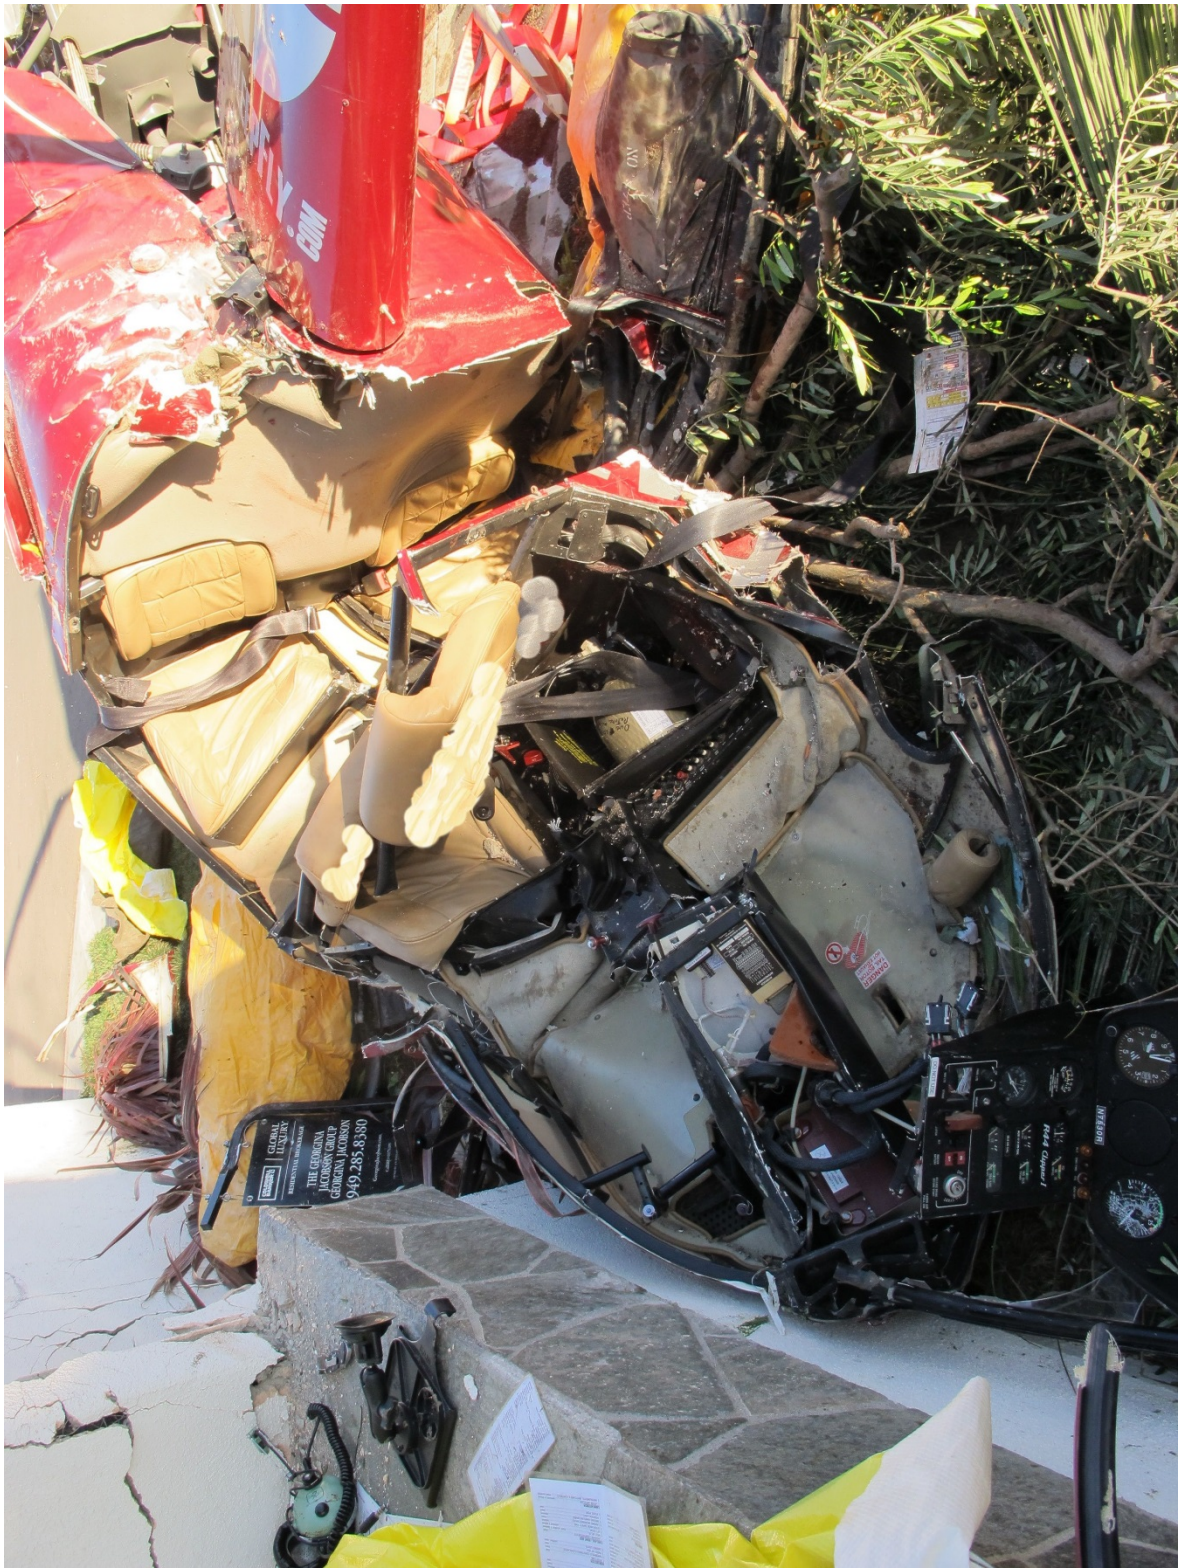
The cabin came to rest with the nose against a house and lying on its left side. First responders cut away the door frames and ceiling.

Cabin area

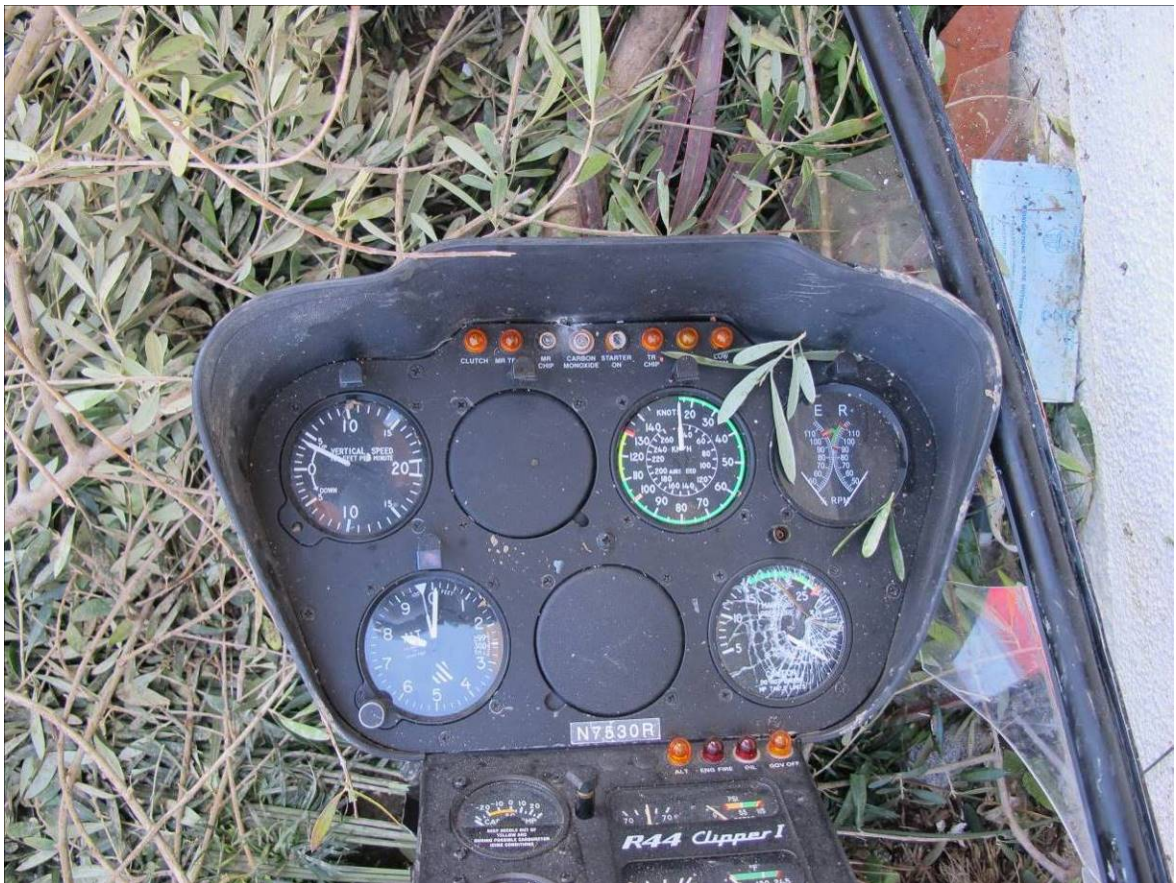
The upper instrument console

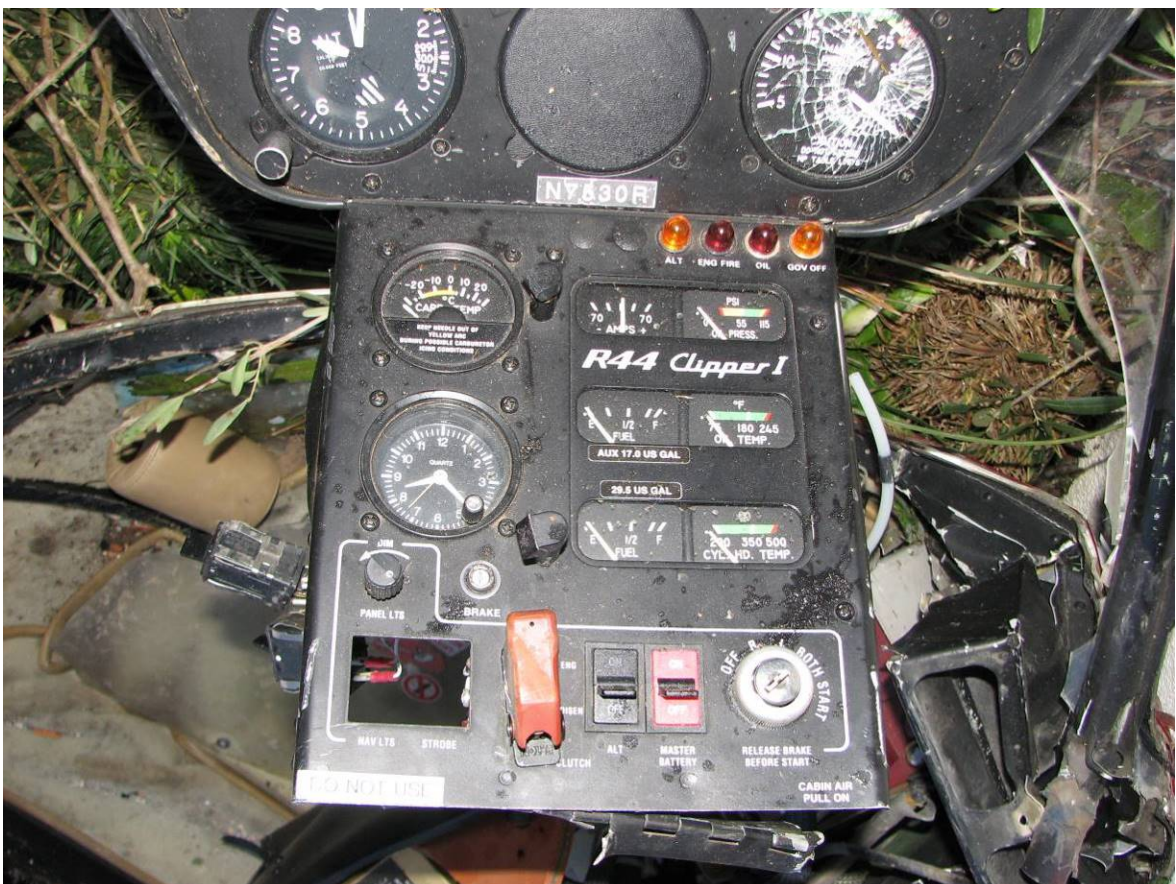
The lower instrument console

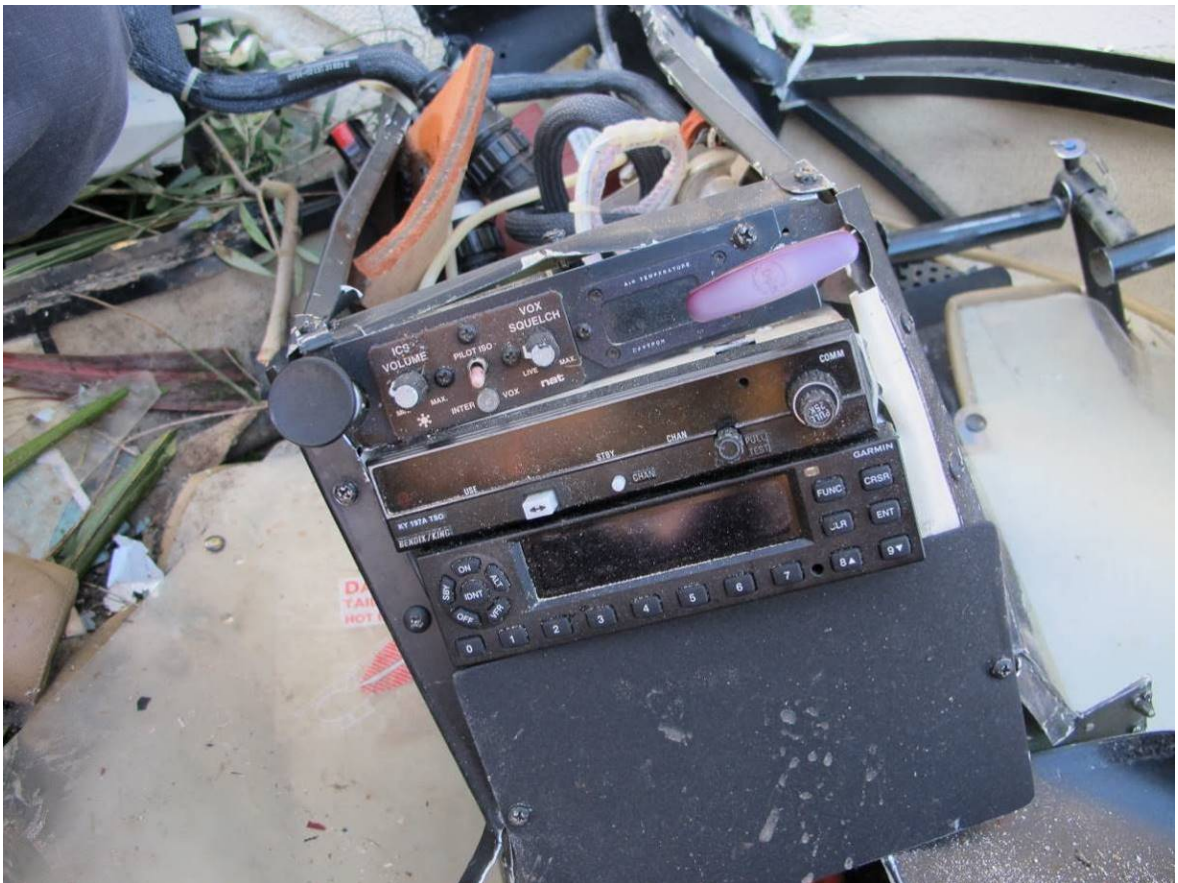
The radio rack

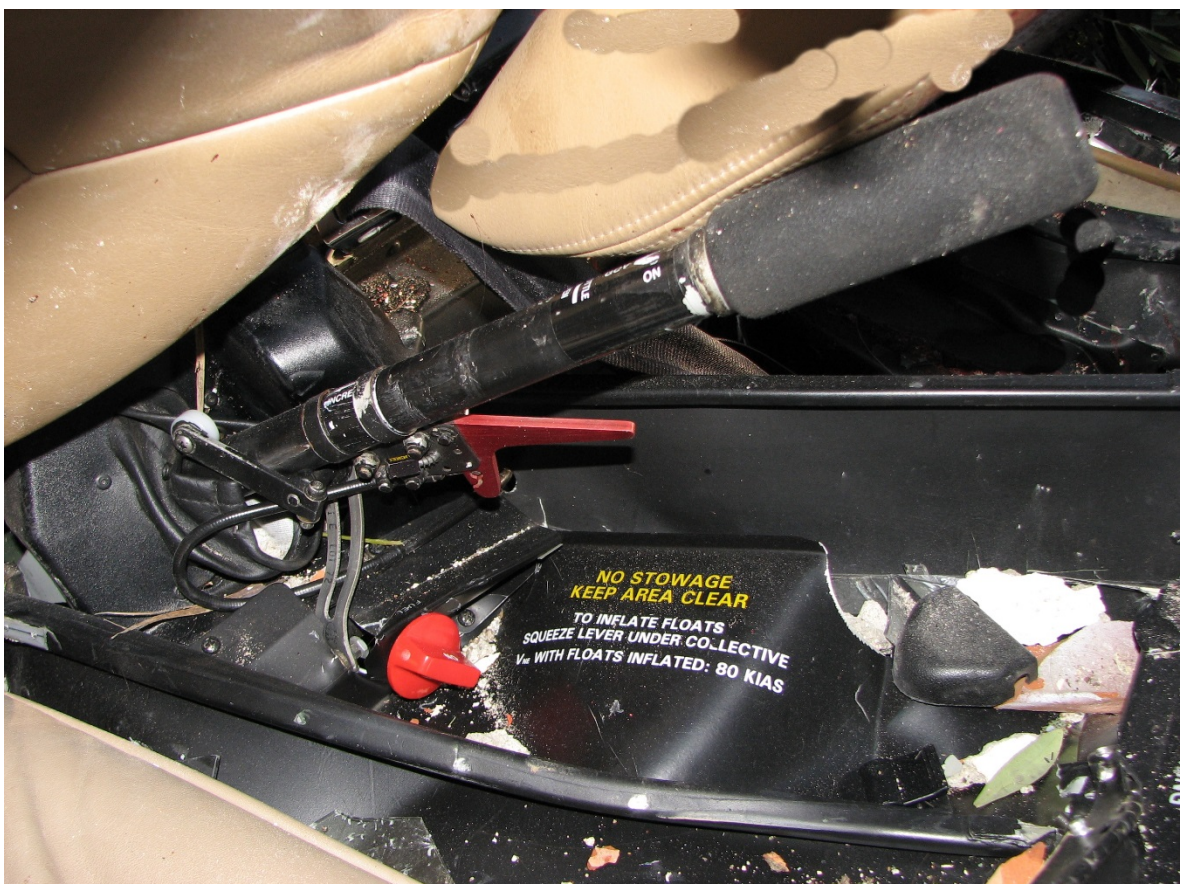
The position of the collective control
